**TRANSPARENCY  
INTERNATIONAL**  
Rwanda

# Comprehensive Environmental and Social Audit of Sampled Infrastructure Projects Against the Safeguarding Criteria in 5 Districts of Rwanda

## FINAL REPORT

## SEPTEMBER 2024

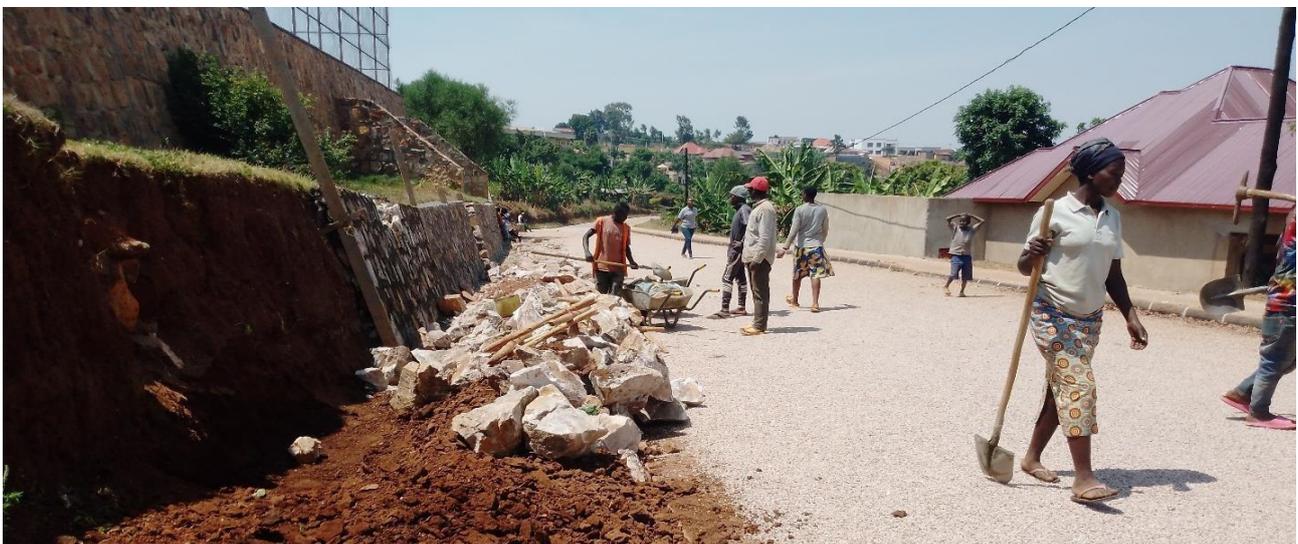
The project faces delays and increasing insurance claims, pushing the timeline into uncertainty due to the failure to prioritize safety measures. The absence of PPE impacts not just the individual but also their colleagues, families, and the broader community, underscoring the significant consequences of seemingly minor lapses in safety protocols. This shows that the project does not meet compliance with occupational health and safety regulations. Here the Ministerial order No 2 of 17/05/2012 determining conditions for occupational health and safety in its article 29 is not complied.

**Picture 1: Personal protective measures for workers not respected**

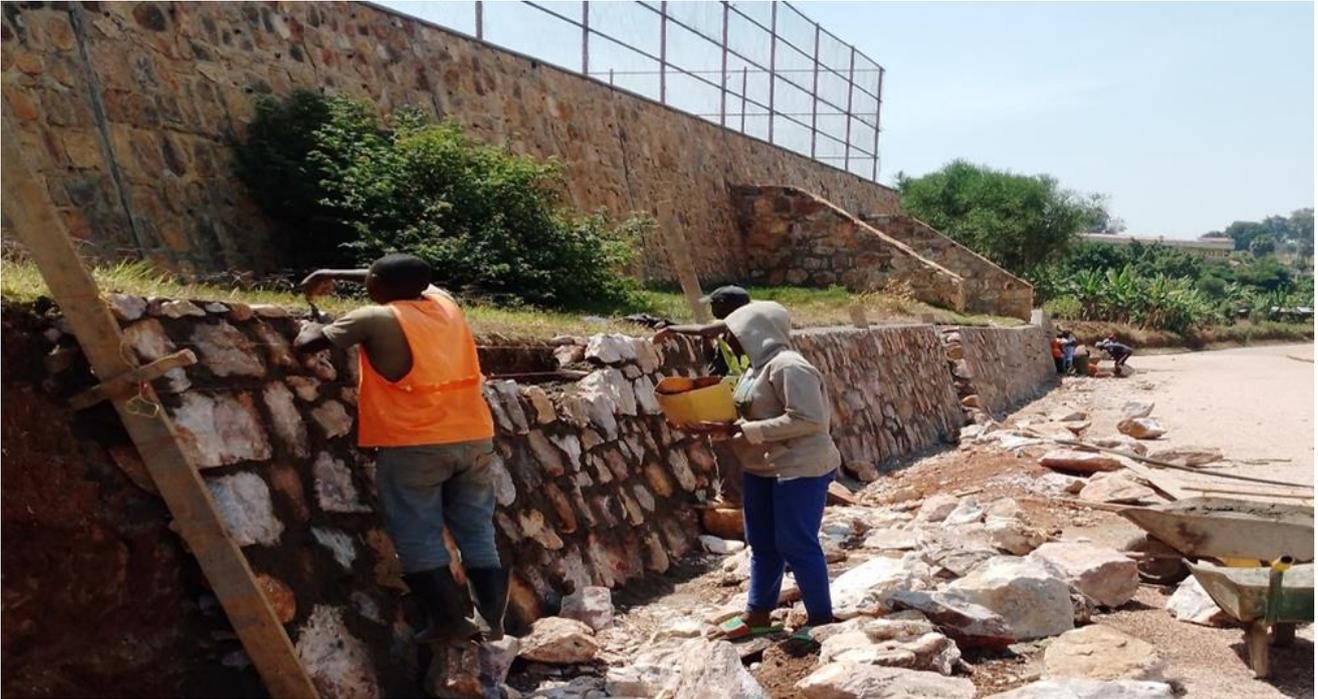
Furthermore, as shown in the picture below, the retaining wall thickness on the top was  $\pm 30\text{cm}$ , middle  $\pm 24\text{cm}$  and bottom width  $\pm 30\text{cm}$ . This does not comply with the RTDA<sup>1</sup> manual where dimensions at bottom width should be more than double top width according to the special height. This can prevent collapsing caused by earth pressure. Technical inspections assessed visually their thickness and find that when the retained soil is much moisture should break these walls, due to their small thickness comparatively to their relative height.

**Picture 2: Retaining wall not complying with its thickness compared to its relative height**

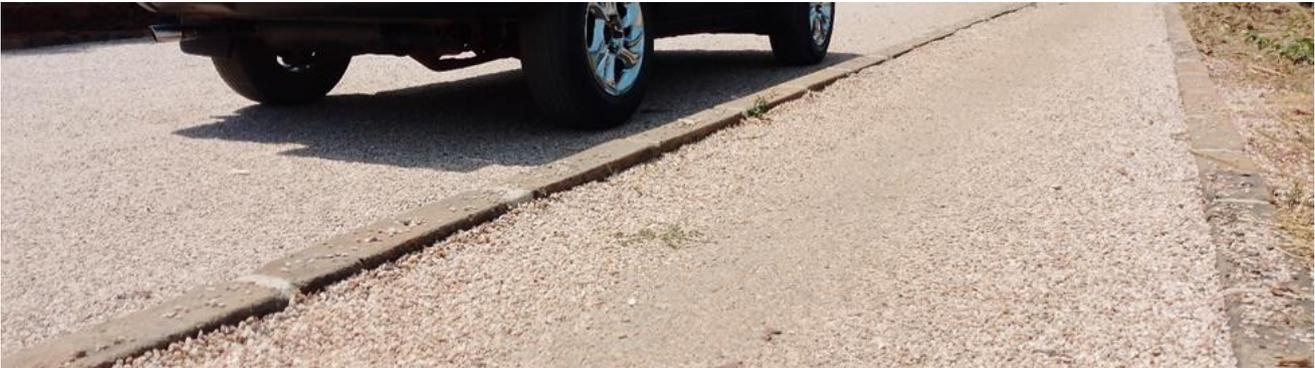
base. It appears that the base was not properly compacted, and the surface of the walkway sits lower than the two adjacent curbs. This design could lead to water stagnation, base layer infiltration, and eventual damage of the road structure(see picture below).

**Picture 3: The whole pedestrian ways along the project must be re-filled to easily facilitate rainwater flow**

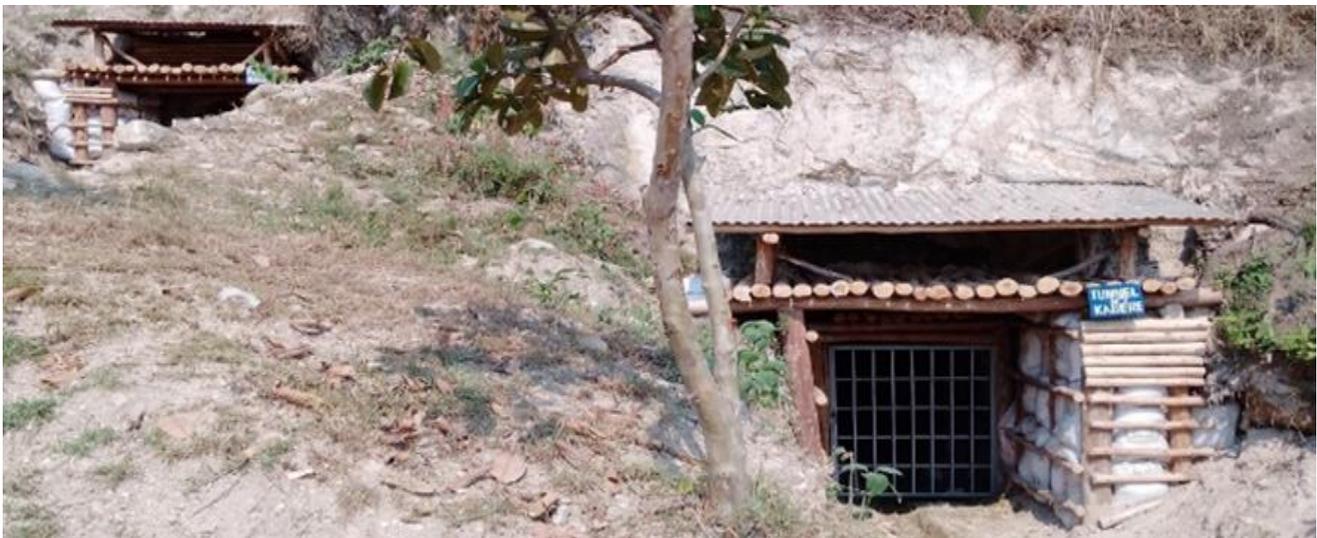
A well-designed and correctly installed mine support system ensures the stability and safety of underground openings. The company claims to have stable soil conditions; however, when encountering loose soil, they use timber supports, as observed at the tunnel entrance. The site complies with the **Rwanda Mining and Quarry Operations Law N° 58/2018 of 13/08/2018**, which mandates that all underground mining operations have proper support systems to ensure stability and worker safety. These support systems must be designed based on geological conditions and the nature of the soil or rock being mined. When loose or unstable ground is encountered, as per the law, operators are required to install reinforcements such as timber, steel supports, or other suitable materials to prevent collapses. The law emphasizes that support systems should be regularly inspected and maintained, with the responsibility resting on the operator to protect the structural integrity of the mine and ensure a safe working environment for miners.

**Picture 4: Tunnel walls and top protection comply with Mine support system**

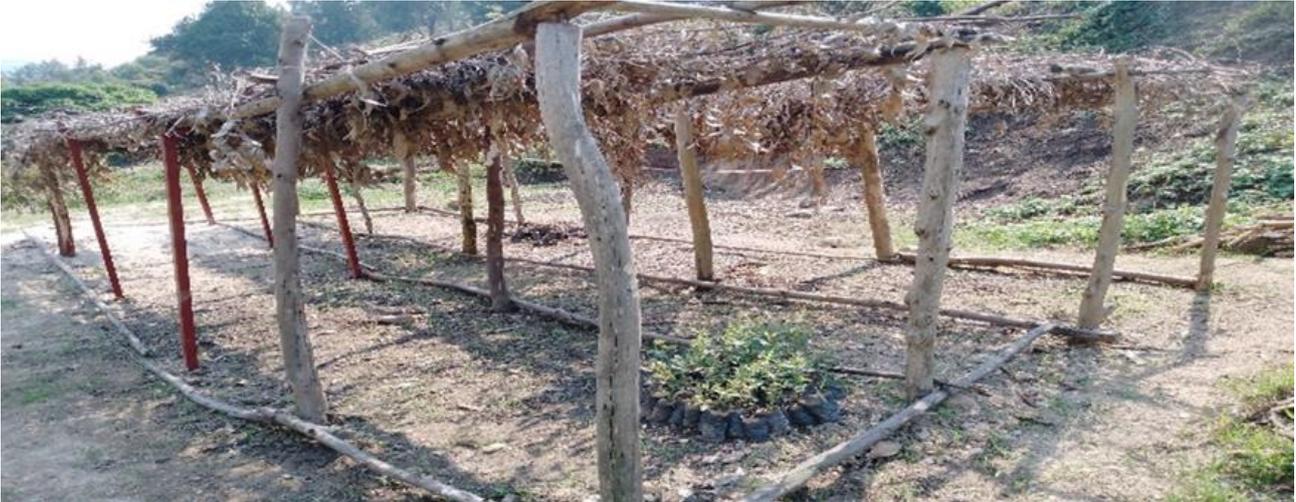
In the Runzenze mining area of Karongi district, there is a commendable practice of developing tree nurseries, which plays a vital role in environmental protection. Establishing tree nurseries in mining activities is crucial for ecological restoration and sustainability, as mining often leads to deforestation, soil degradation, and habitat loss. By cultivating trees, mining companies can rehabilitate impacted areas, reintroducing native vegetation, stabilizing soil, and enhancing biodiversity. Additionally, trees help reduce carbon emissions and combat climate change. This initiative also encourages community involvement and offers local employment, contributing to both ecological restoration and social benefits in mining-affected areas. The site complies with **Rwanda Mining and Quarry Operations Law N° 58/2018 of 13/08/2018**, which mandates environmental restoration as part of post-mining rehabilitation efforts. Mining companies are required to establish tree nurseries to support reforestation and land restoration in areas impacted by mining activities. This includes planting native tree species to stabilize the soil, prevent erosion, restore biodiversity, and improve ecological balance.

**Picture 5: Trees nursery is established to support reforestation and land restoration**

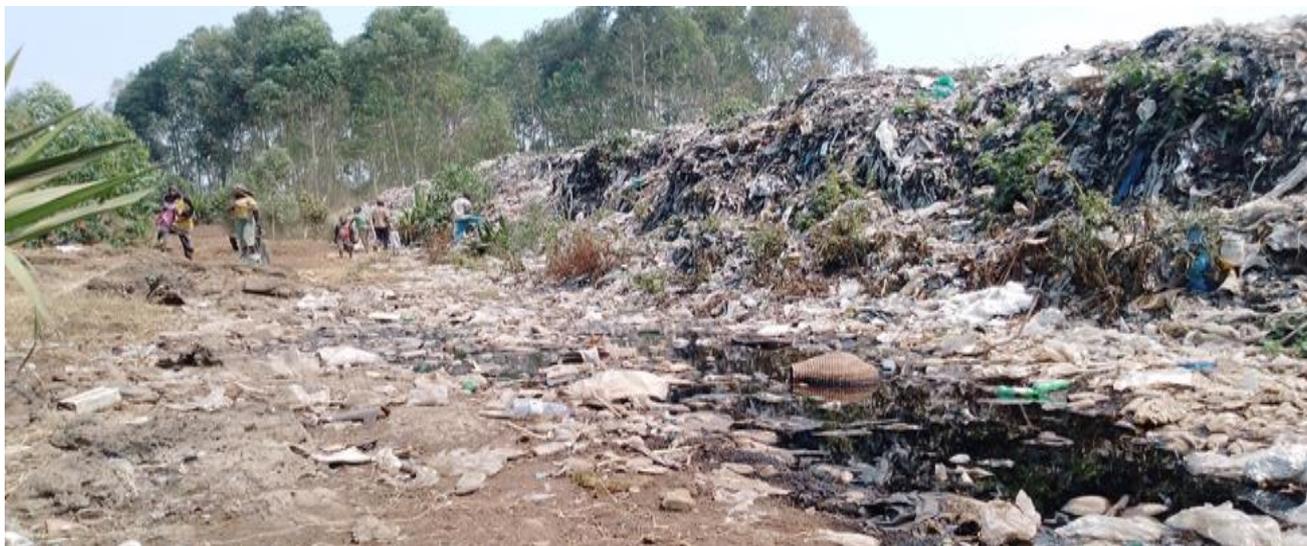
Security measures are severely lacking, with no access control or surveillance. Children frequently enter the site to scavenge, and domestic animals roam freely. This does not comply with the Law n° 39//22001 of 13 September 2001 establishing the Rwanda Utilities Regulatory Agency (RURA) of certain Public Utilities, in its ARTICLE 1 highlighting its mandate to regulate sanitation services, and stipulate that the site must effectively be fenced or otherwise secured to prevent unauthorized entry<sup>3</sup>.

***Picture 7: Kids collecting metals, bottles, plastics materials and other small things they find important to return back at their homes or elsewhere. The site does not have fence nor security personnel and anyone from outside can enter freely***

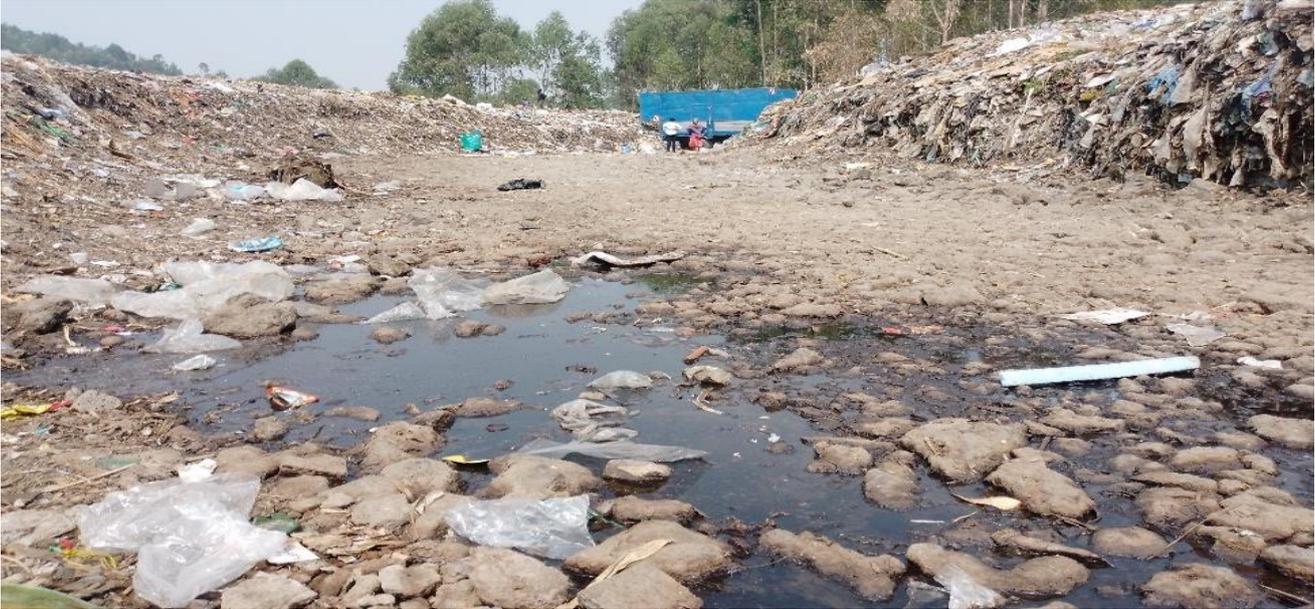
The accessibility to this dumping site is good, road is wide and rough to facilitate truck for efficient waste transportation and operational effectiveness. However, some waste deposits still observable within site roads

**Picture 8** Leachate observable within roads in dumping site

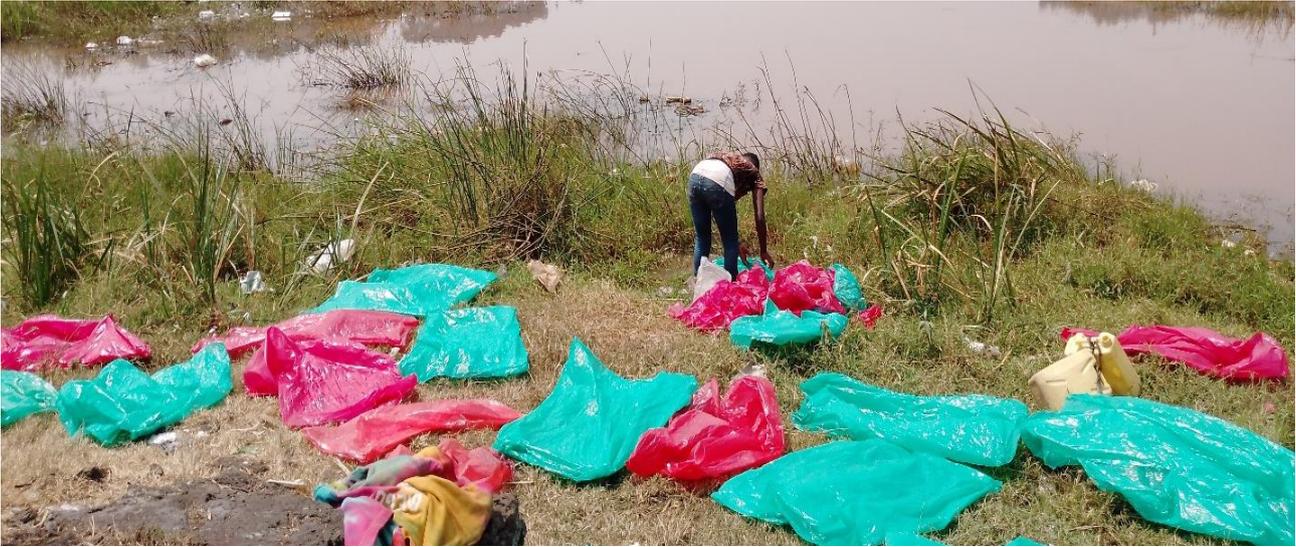
**Picture 9: People are washing their cloth using contaminated water from the dumping site**

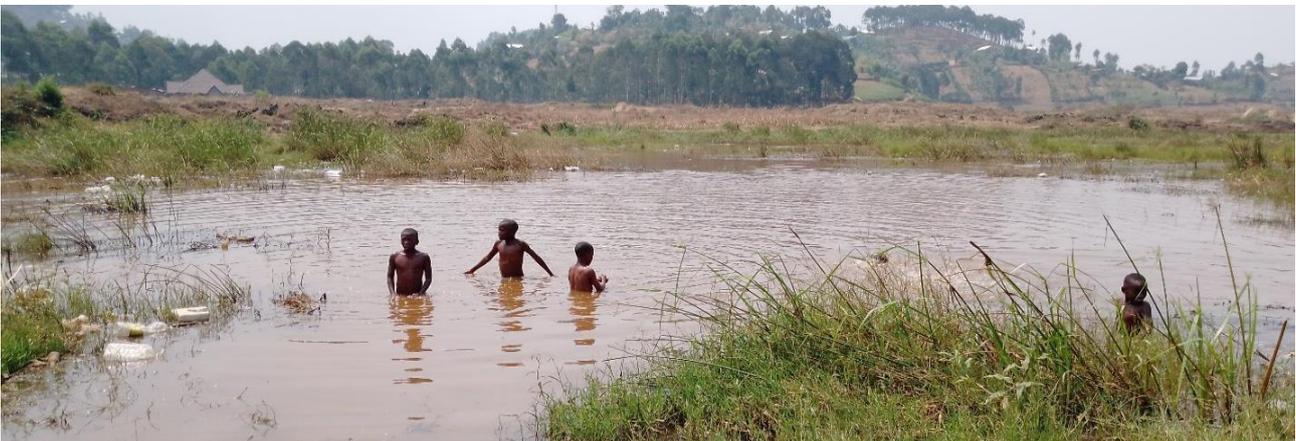
**Picture 10: Kids swimming in this turbid water as natural pool located within 30meters from dumping site**

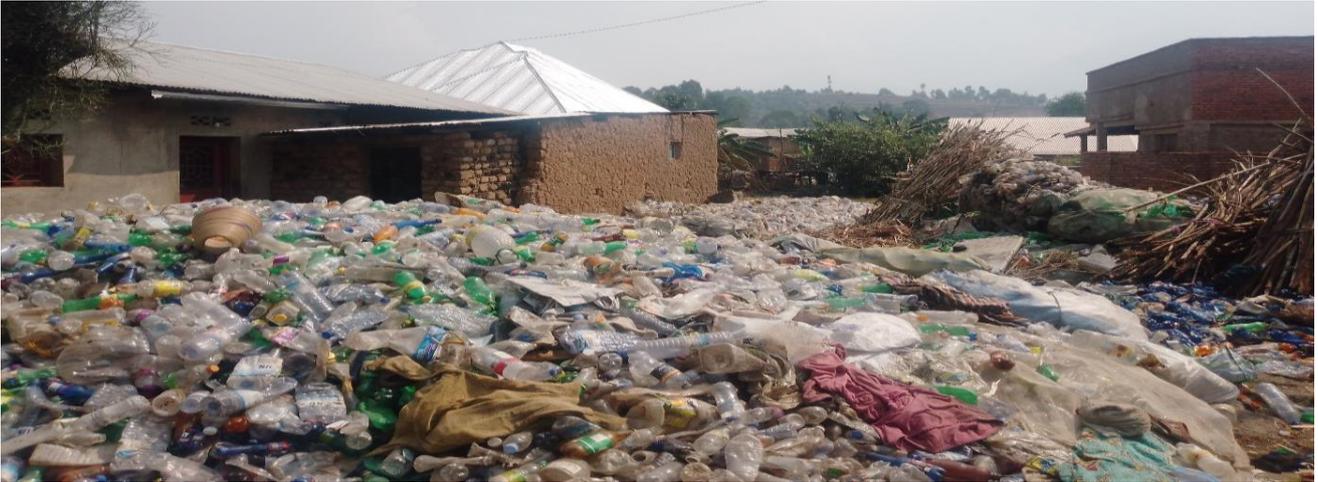
**Picture 11: Residential houses within dumping site**

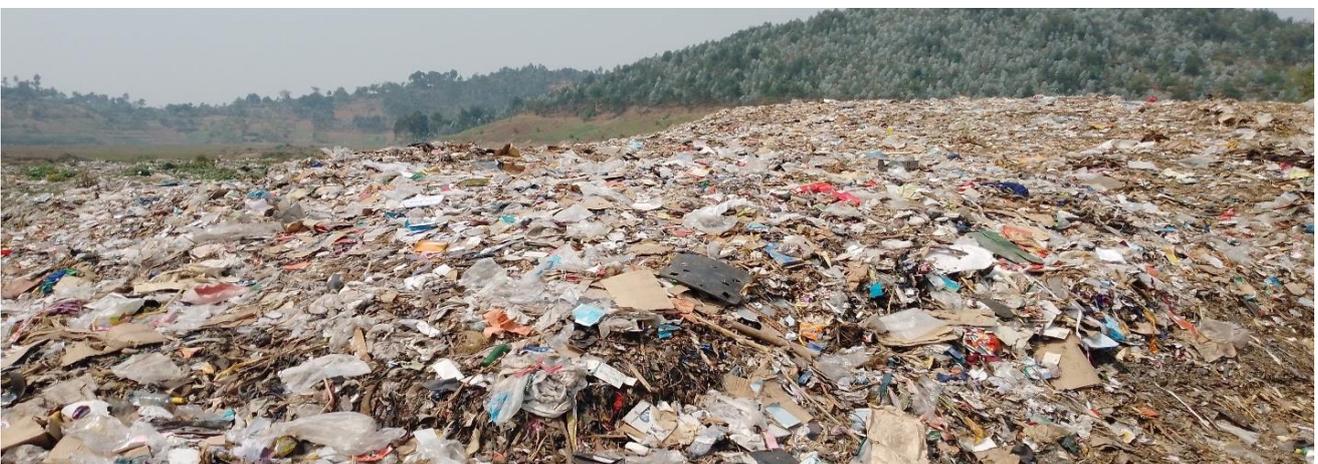
**Picture 12: There is no inspection to identify any hazardous or prohibited materials in order to prevent contamination of the landfill and ensure compliance with environmental regulations**

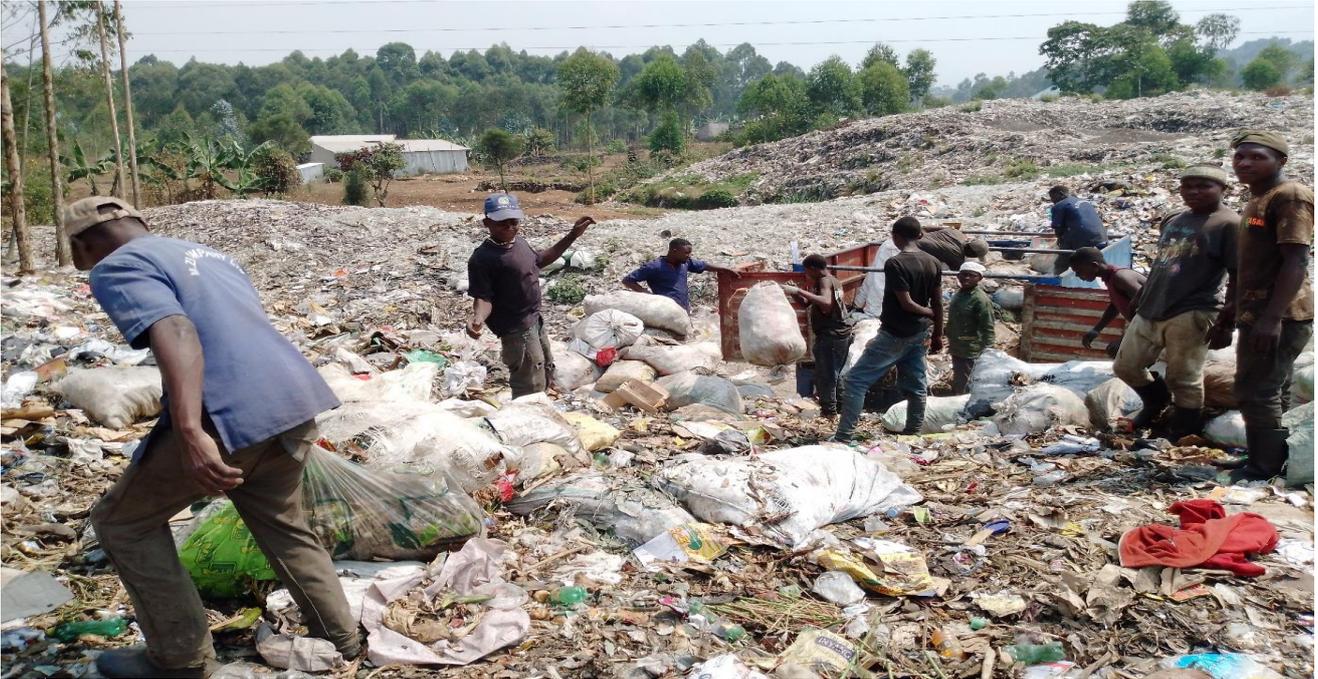
**Picture 13: Workers without wearing masks, boots, gloves or any other protective material for hazards waste handling**

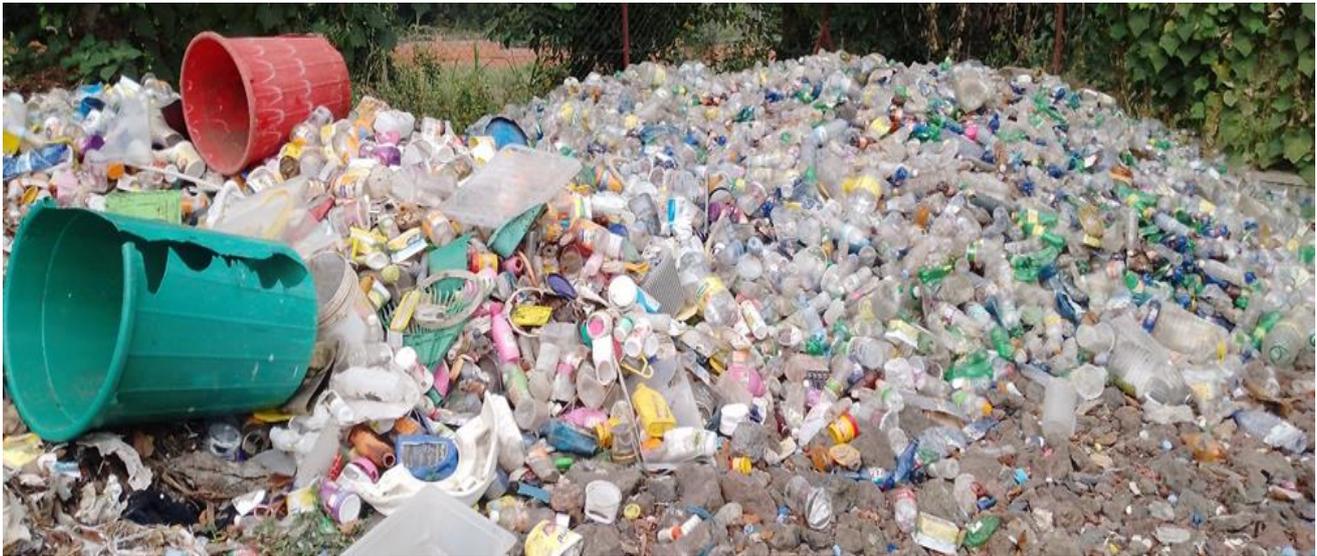
**Picture 15: Plastic waste collected**

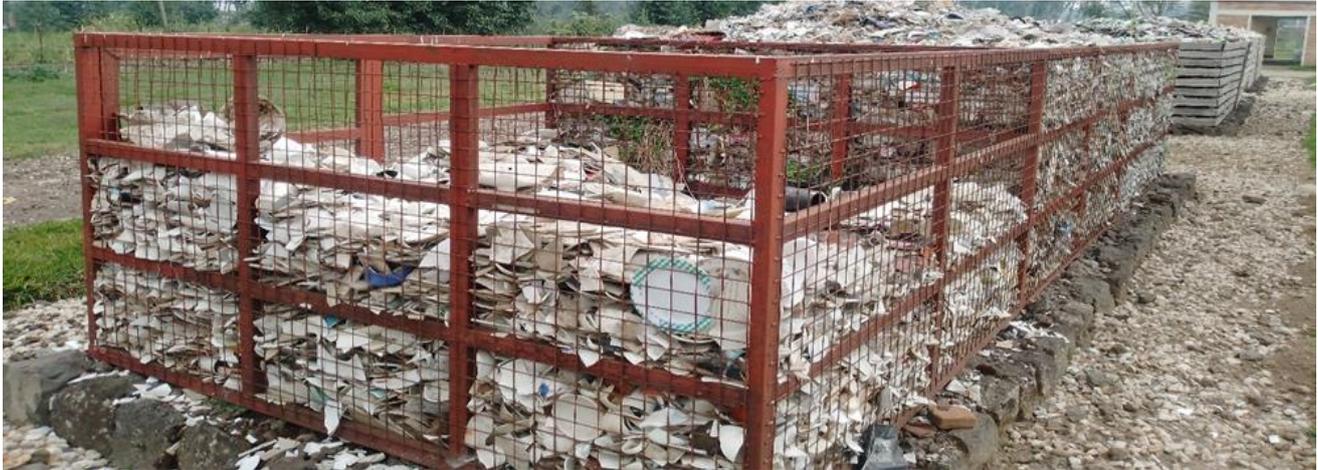
**Picture 16: Ceramic materials, bottles, metals kept in different open bins**

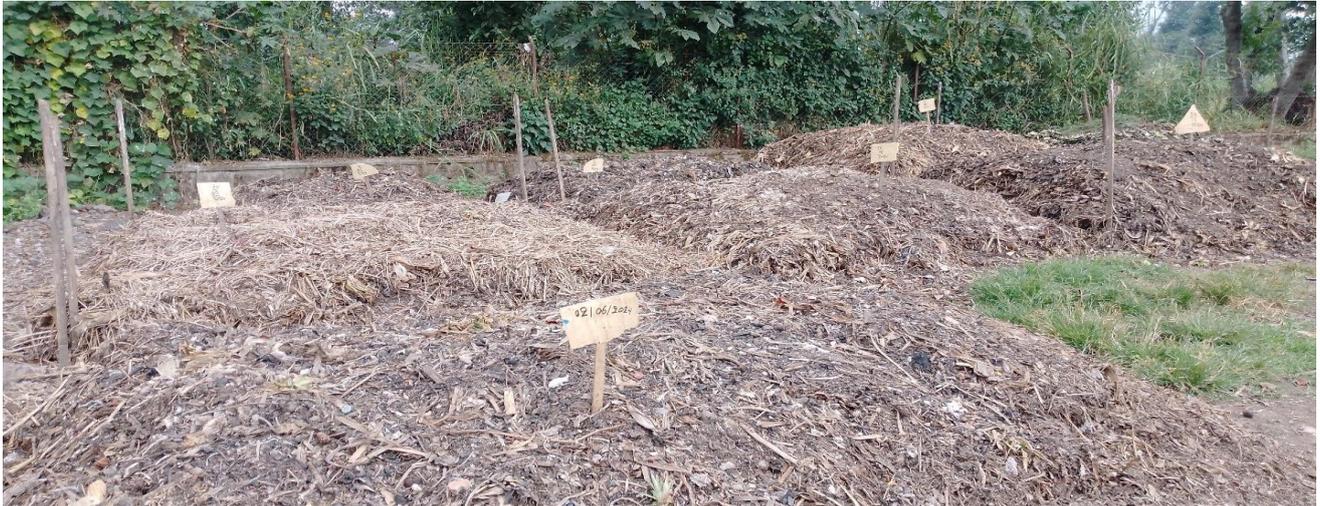
**Picture 17: Preparation of compost manual from domestic organic waste in 90 days**

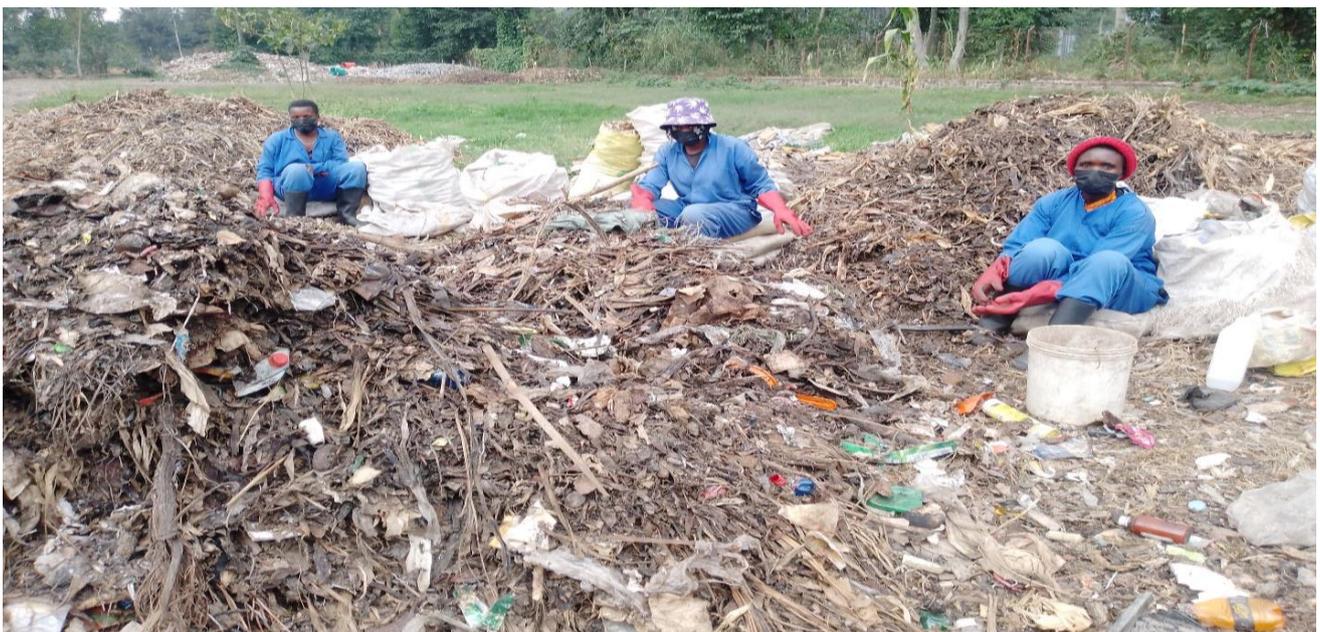
**Picture 18: Workers segregating domestic waste wearing PPE**

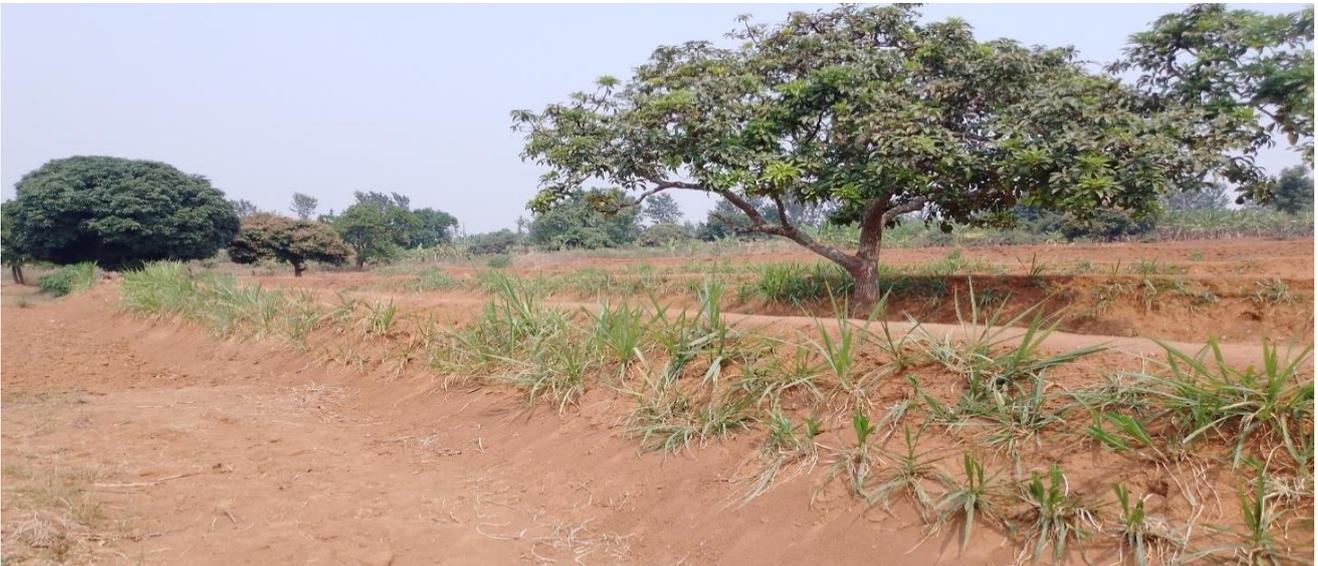
**Picture 19: Cyohoha terraces site**

The absence of key compliance items like a guideline site, Environmental and Social Impact Assessment (ESIA), and Resettlement Action Plan (RAP) for the Commercialized and De-risking for Agricultural Transformation (Terracing in Bugesera District) project poses serious environmental and social risks. Without a guideline site, there is no structured framework for workers and stakeholders to follow during the project, leading to inconsistencies in operations and potential non-compliance with environmental and safety standards. The lack of an ESIA means the project may have failed to assess its environmental impact adequately, increasing the risk of negative effects such as habitat destruction, water contamination, or biodiversity loss. Furthermore, the absence of a RAP suggests that the project has not addressed the social implications of the transformation, such as land displacement or loss of livelihoods, which could fuel conflicts with the local community and lead to mistrust of the project's objectives.

Additionally, the absence of critical reports and plans like the Environmental and Social Management Plan (ESMP) implementation report, waste management report, and community grievance report highlights gaps in ongoing project accountability and stakeholder engagement. Without an ESMP report, there is no way to track whether environmental safeguards are being effectively implemented, increasing the risk of soil erosion, degradation, and improper waste disposal. A missing community grievance report means that local concerns about the project may go unheard, causing frustration and potentially leading to protests or social unrest. The lack of a Gender-Based Violence (GBV) outreach plan, Personal Protective Equipment (PPE) for workers, and soil quality monitoring further exacerbates the situation. Without these, the project risks neglecting the protection of vulnerable groups, worker safety, and long-term environmental sustainability. In particular, the absence of soil erosion and quality monitoring plans could lead to accelerated land degradation, undermining the very goal of agricultural transformation by reducing the future productivity and sustainability of the terraced lands.

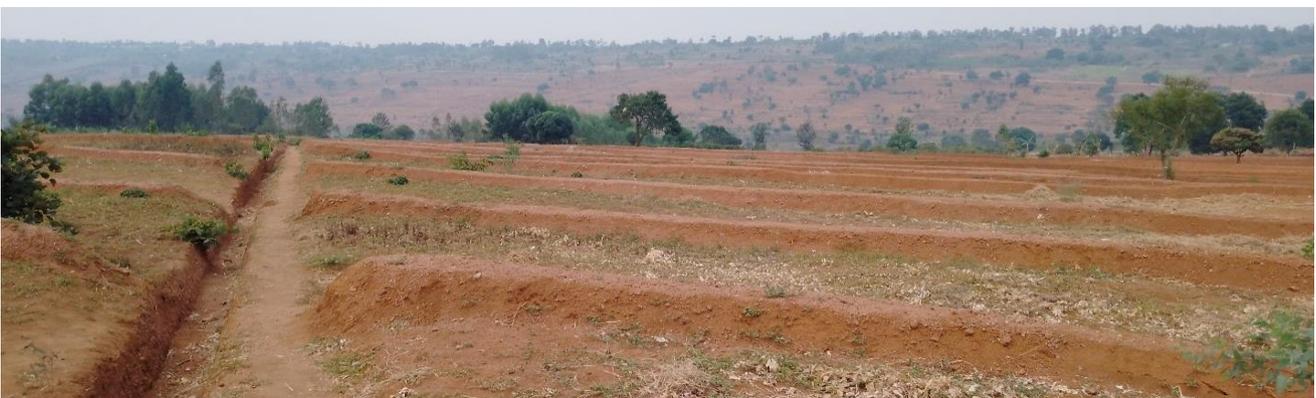
**Picture 20: The field looks of moderate slope, Width and intervals of terrace benches keep changing but within acceptable limits**

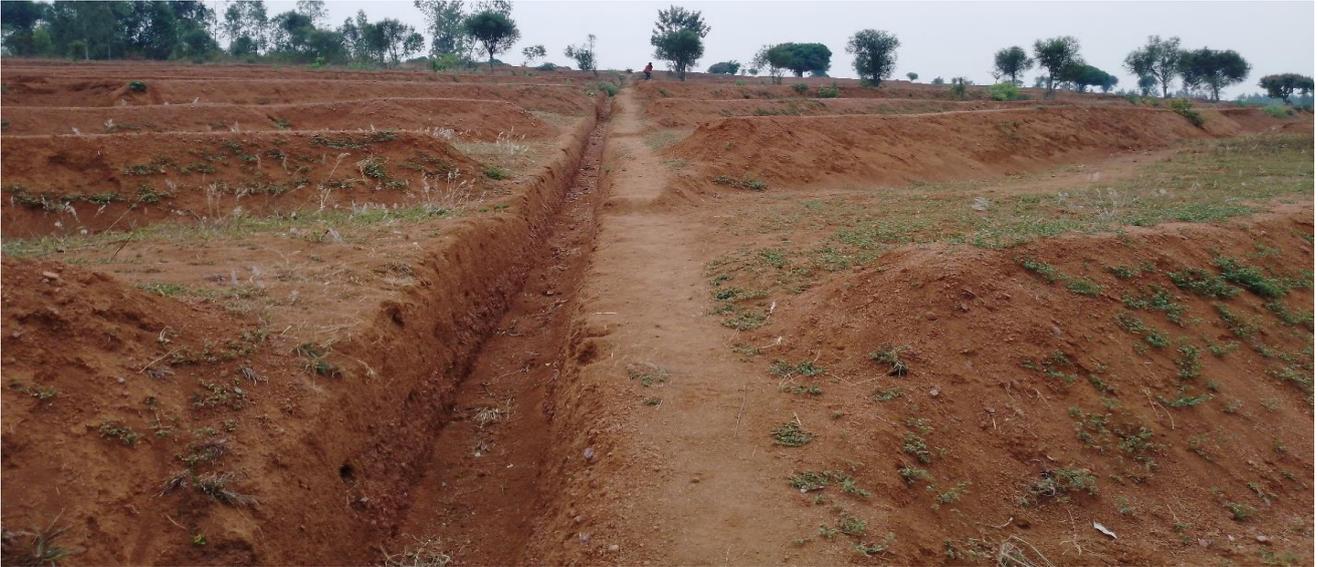
**Picture 21: Main waterways to receive rainwater flow when infiltration excess is attained towards Cyohoha marshland & lake**

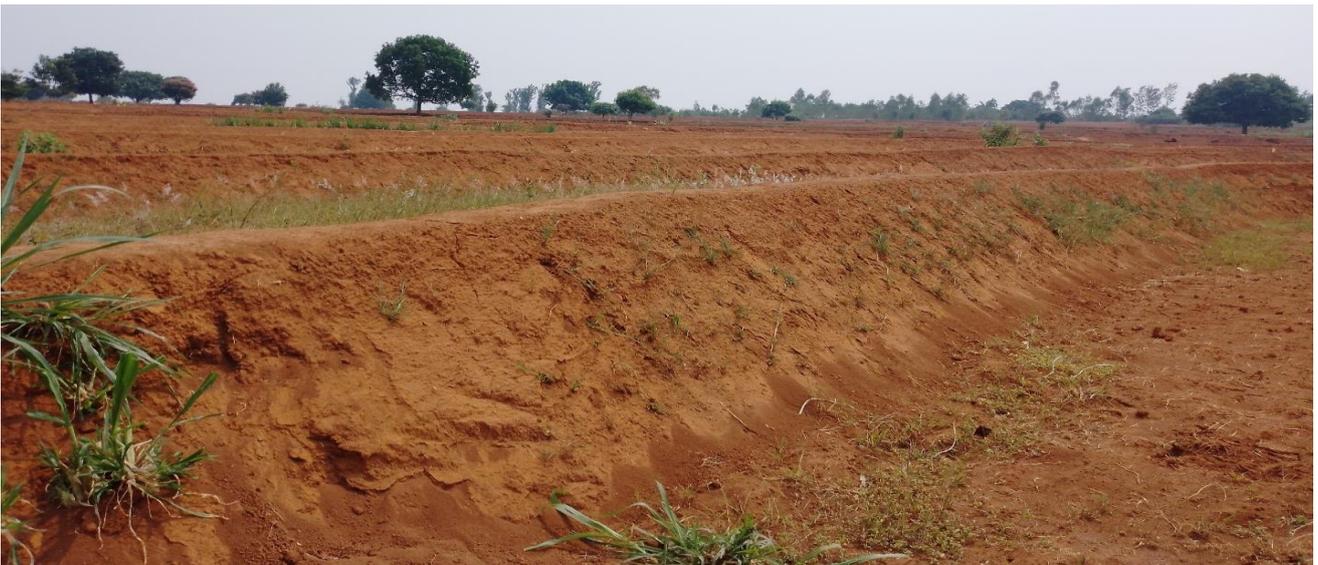
**Picture 22: Supervisor team says will use Cacamega grass to protect risers, as by physically seen the slope keeps deteriorating even by wind, soil is sandier and can't be compacted enough to resist. Better use appropriate measures to resist even when the rain peri**

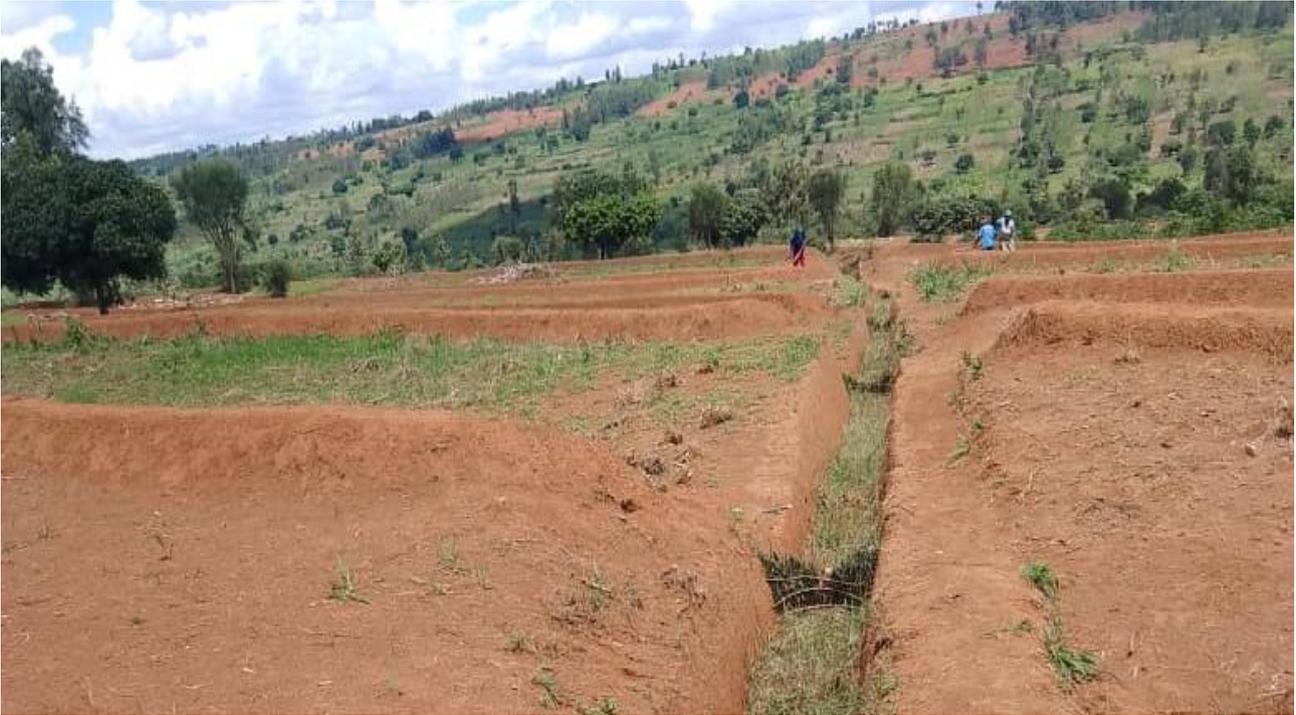
**Picture 23: Natural blockers installed within waterways to delay flow as well as facilitate high infiltration, enhancing moisture levels and promoting healthy crop growth**

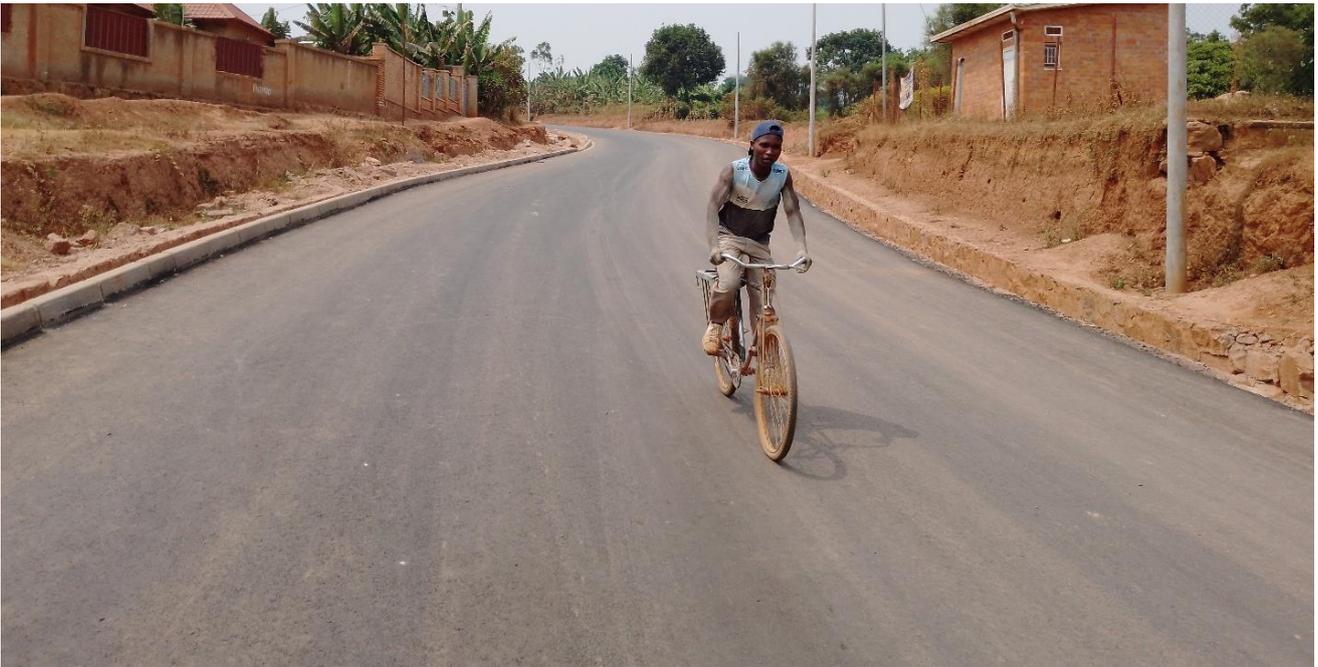
**Picture 24: Asphalt wearing course finishing**

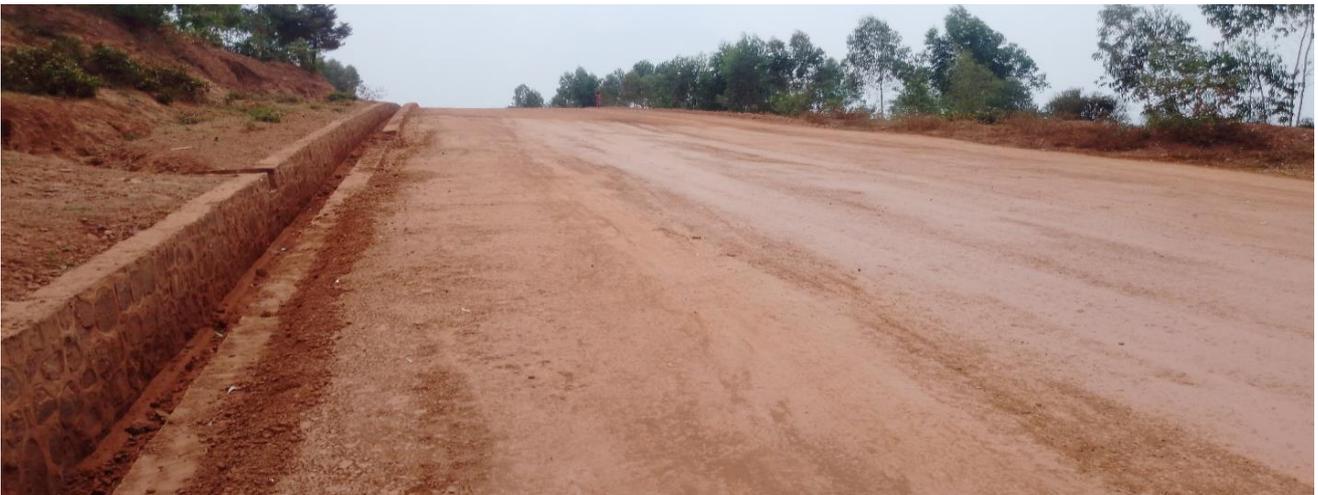
**Picture 25: No enough sight visibility at the top, dealing with existing ground levels will be effective**

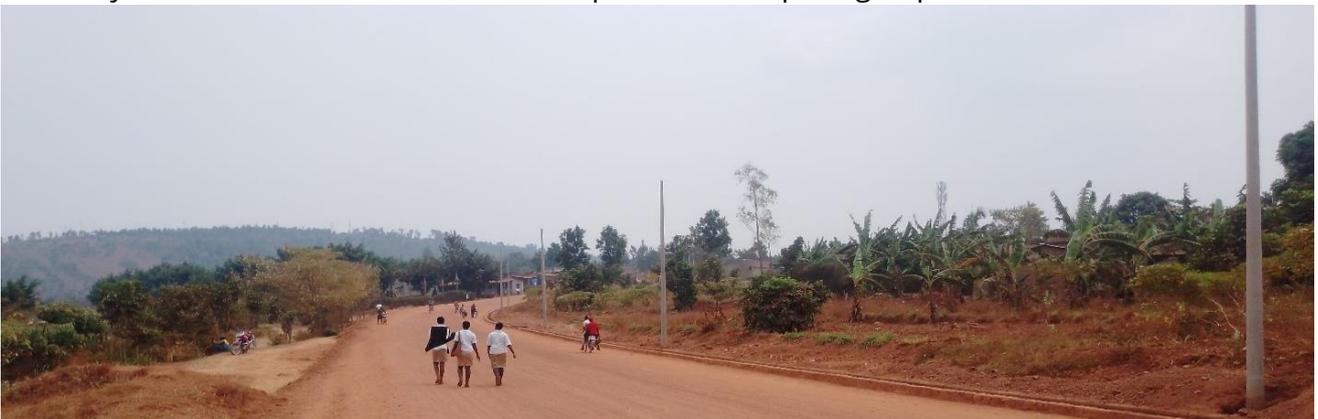
**Picture 26: Installed electrical poles reserved for public lights**

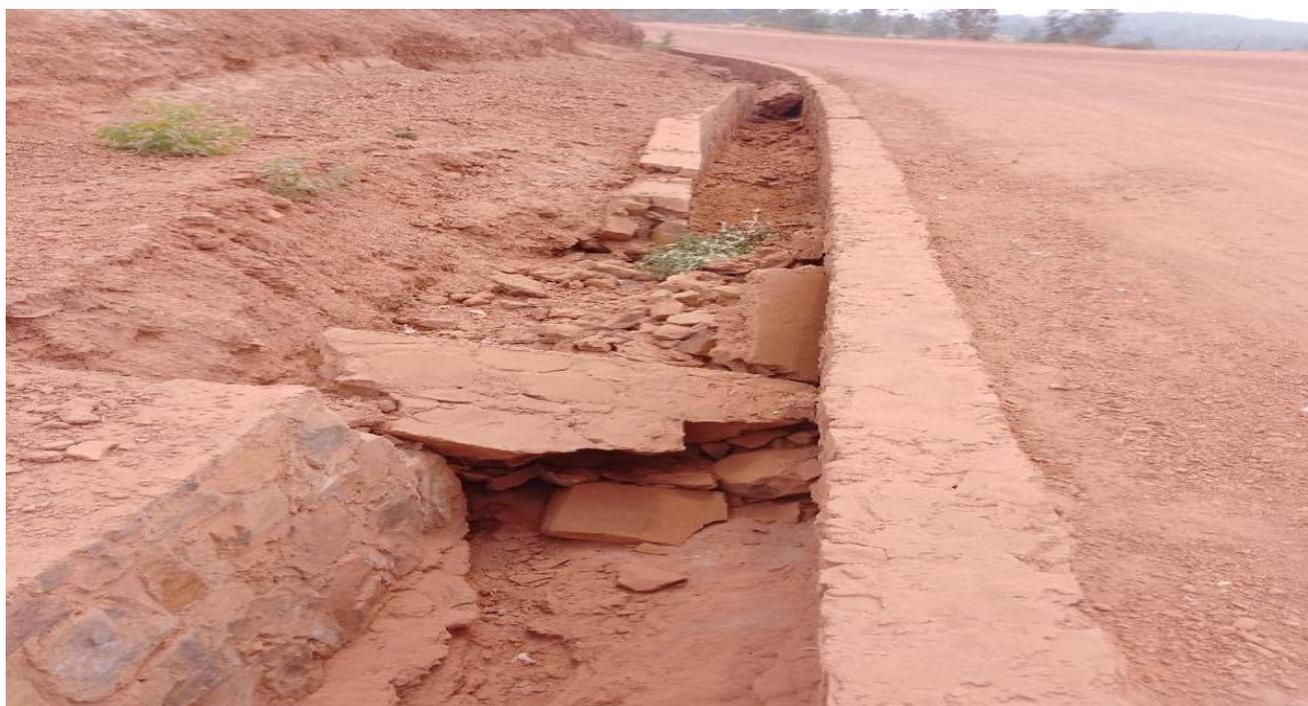
**Picture 27: Collapsed side drains caused by earth pressure, long height and non-paved ditch bottom floors**
